WILKO PAINT TROUBLESHOOTING TIPS

CAUSE - REPAIR - PREVENTION

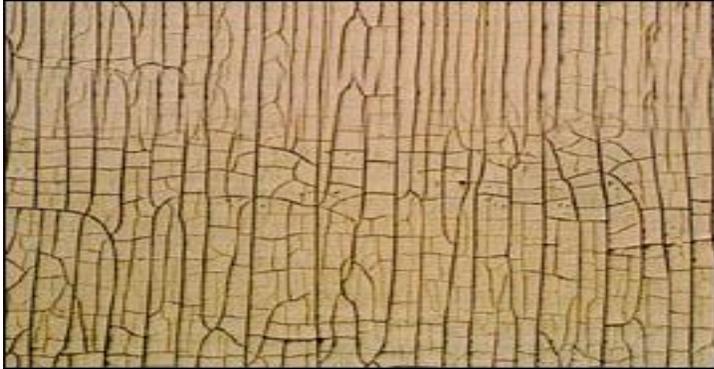
ALLIGATORING

Description: Patterned cracking in the paint film resembling the scales of an alligator. These cracks generally do not expose the substrate (e.g. the surface that has been painted).

1. Natural aging of oil-based paints due to temperature fluctuation. The constant expansion and contraction results in a loss of paint film elasticity.
2. Application of an extremely hard, rigid coating, like oil enamel, over a **softer**, more flexible coating.
3. Application of a topcoat before the primer or the base coat is dry.
4. Application of a coating over a glossy finish.

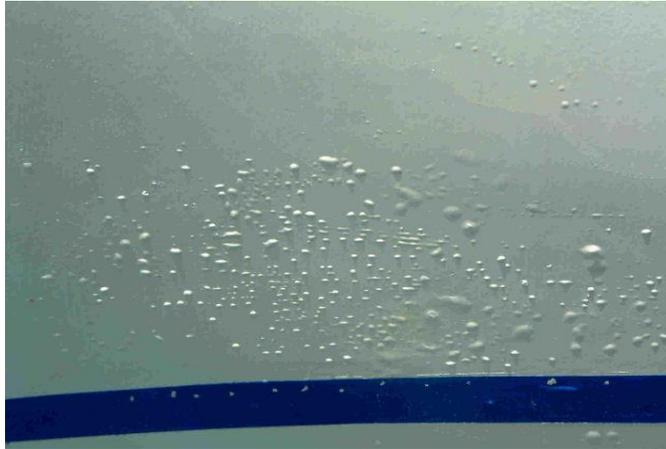
Photo

BLISTERING

Description: (Pimples, Bubbles, Bumps) Swelled areas appearing as pimples or bubbles in the topcoat film, often months after application.

1. Moisture trapped beneath the paint film due to:
 - a. Improper dry time after wet sanding
 - b. Contaminated air lines
 - c. Spraying in extreme high humidity conditions.
2. Trapped solvents from applying wet heavy coats with insufficient flash time between coats.
3. Improper dry time of undercoats before top coating.
4. Painting over grease, oil or rust.

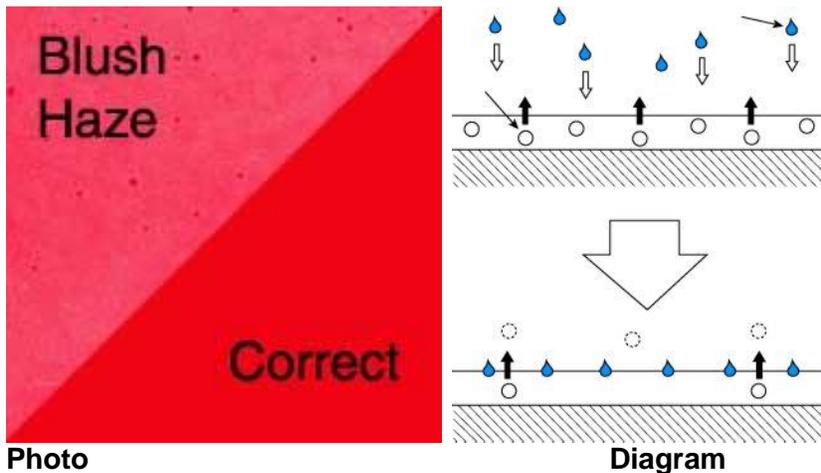
BLUSHING

Description: (Milkiness) A milky/opaque gray cloud appears on the surface of the paint film immediately or shortly after application. If cured during conditions of cool ambient temperatures, dropping temperatures, or high humidity, amine-cured epoxy resin coatings can develop a surface oiliness or exudates, commonly referred to as "amine blush" or "sweating". This is caused by the absorption of carbon dioxide and water into the coating film and its reaction with the amine-curing agent. Some of the problems can be: surface tackiness or greasiness, incomplete cure, poor adhesion, poor adhesion on over-coating, coating discoloration over time, poor gloss retention.

1. When spraying during humid conditions, air from the spray gun and solvent evaporation lowers the substrate temperature below the dew point, causing moisture in the air to "condense" in or on the paint film.
2. The condition is aggravated when a too fast drying or unbalanced thinner/reducer is used.

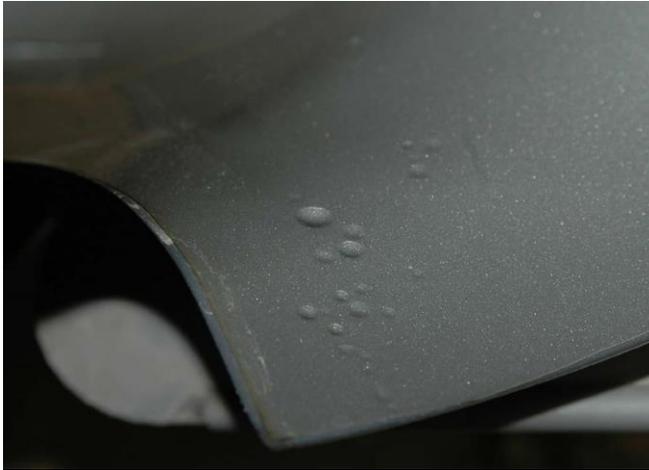
BUBBLING

Description: (Foaming/Cratering) Formation of air bubbles (foaming) and resulting small, round concave depressions (cratering) when bubbles break in a paint film during drying.

1. Introduction of air into the paint solution by shaking a partially filled can of paint, or using too high of a speed when using a drill/mixer.
2. Excessive brushing or rolling – i.e., applying paint too rapidly – will drive excess air into the film.
3. Use of a roller cover with wrong/excessive nap length (ex. using a 3/8" when 1/4" is recommended).
4. Applying a gloss or semi-gloss paint over a porous or unsealed surface.
5. Forced high heat during application speeds up drying; bubbles or craters that form will dry before they can break and level out.
6. Using a thinner/reducer that is inappropriate for the coating.

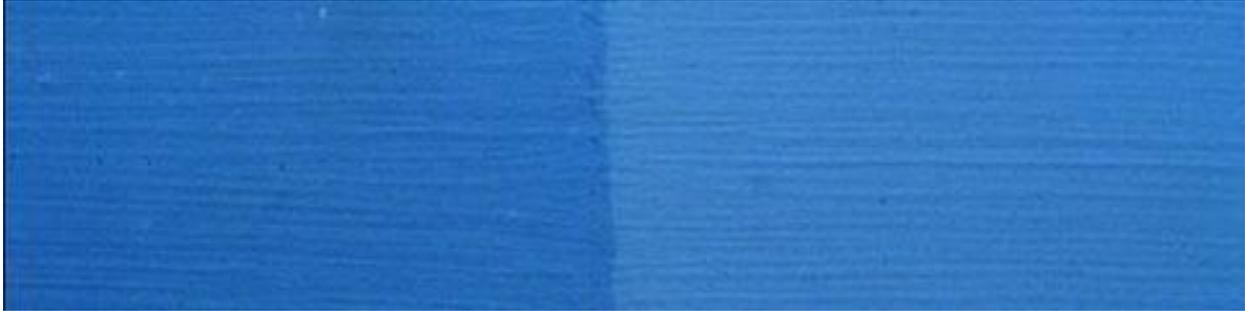
CHALKING

Description: (Powdering) The formation of fine, white powder on the surface of the paint film due to weathering, which may give the appearance of color fading. Although some degree of chalking is normal and can be a desirable way for a paint film to wear, excessive paint film erosion may result in heavy chalking.

1. Oil-based paints and epoxy primers tend to chalk more than water-borne (latex) formulations.
2. Use of a low quality, highly pigmented paint.
3. Factory-finished siding can develop an excessively thick chalk layer and may require power washing to ensure complete chalk removal.
4. Use of an interior paint for an outdoor application.
5. Not adequately sealing a porous surface.
6. Over-thinning a coating (e.g. paint or stain).
7. Allowing an epoxy primer to remain outdoors for an extended period of time before a topcoat is applied.

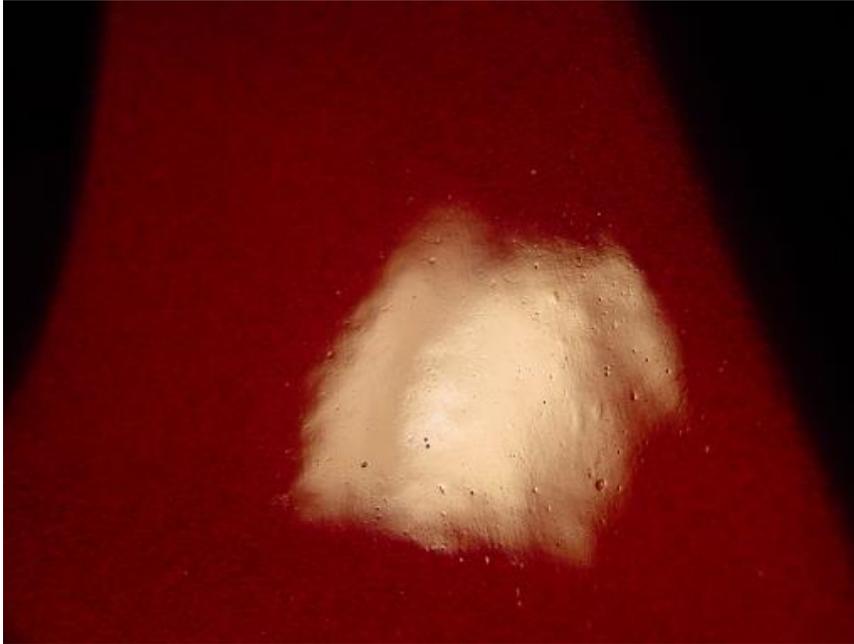
Photo

DUST CONTAMINATION - very common

Description: (Dirt in finish) foreign particles become embedded in paint film.

1. Inadequate cleaning of the surface to be painted.
2. Dirty spraying environment.
3. Inadequate air filtration or unfiltered air entering the booth.
4. Dirty or unsuitable work clothes that contain dust, lint, or fibers.
5. Particles from deteriorated air supply lines.
6. Using a poor grade masking paper.
7. Dirty spray gun.
8. Removing the vehicle from the spray booth before the finish is "dry and dust free".

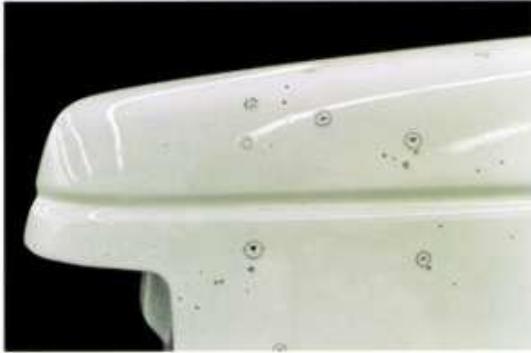
Photo

FISHEYES

Description: (Silicone Contamination, Cratering) Small circular, crater-like openings that appear during or shortly after the spray application.

1. Spraying over surfaces contaminated with oil, wax, silicone, grease, etc.
2. Use of thinner/reducer in place of a solvent cleaner.
3. Spraying over previously repaired areas containing "fisheye eliminator" additive.
4. Using spray equipment (gun, lines, compressor) contaminated with oil, wax, silicon, grease,

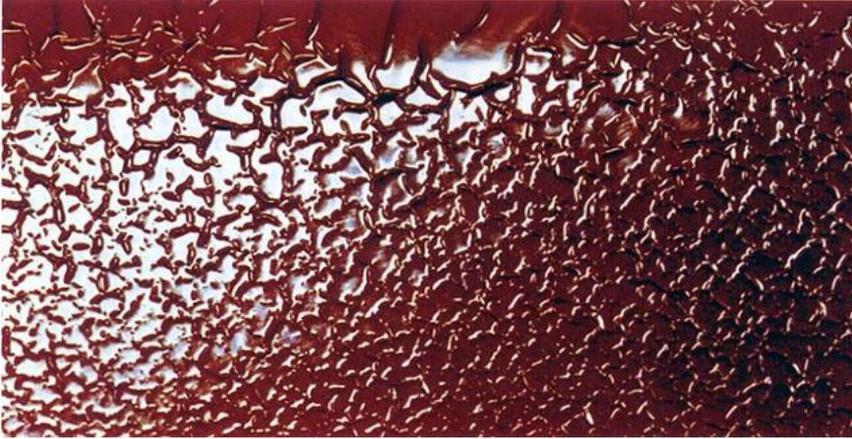
LIFTING

Description: (Wrinkling, Raising, Alligatoring, Shriveling, Swelling) the existing paint film shrivels, wrinkles or swells during new finish application or drying.

Solvents in a newly applied product attack the previous finish causing wrinkling, raising, or puckering of the paint film due to:

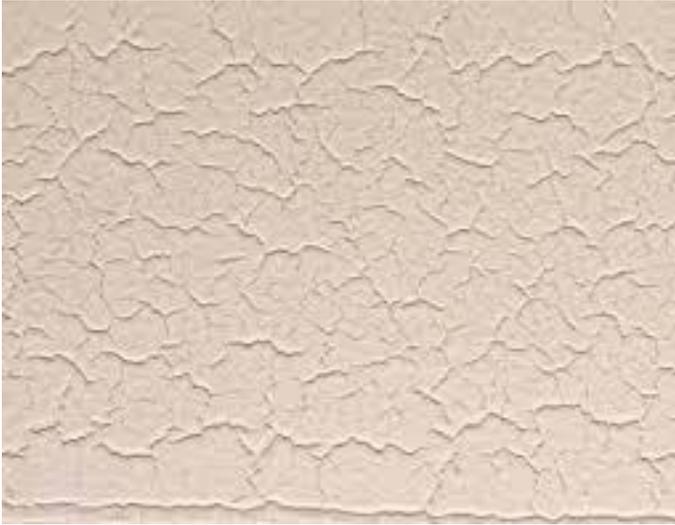
MUD CRACKING

Description: Deep, irregular cracks resembling dried mud in the dry paint film.

1. Paint is applied too thick.
2. Forced drying of a heaving coating application.
3. Paint is allowed to build up in corners during application.
4. Surface was not prepared properly; contaminants were not removed.

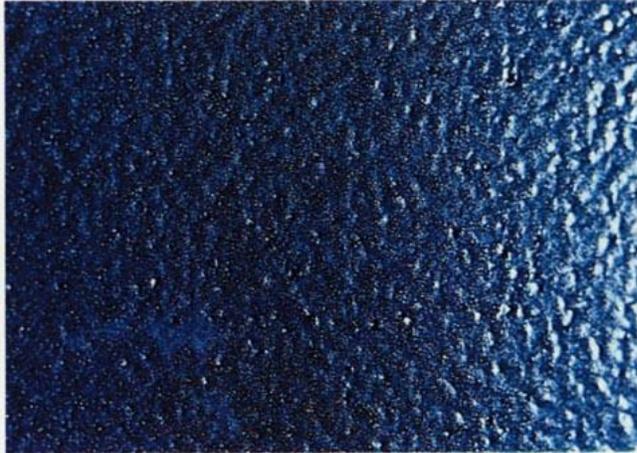
ORANGE PEEL - one of the most common issues.

Description: (Poor Flow, Texture) uneven film formation with hills and valleys in paint resembling the skin of an orange. The defect can be caused by improper application technique where the spray gun is too close to the surface or the air pressure is too low for proper atomization of the paint.

1. Under reduction and/or air pressure too low.
2. Thinner/reducer evaporates too fast for spray conditions.
3. Excessive film thickness or piling on of heavy wet coats.
4. Improper spray gun set-up.
5. Improper painting technique.
6. Aggressive blast profile (> 3 mils) that is not filled in with good epoxy primer.

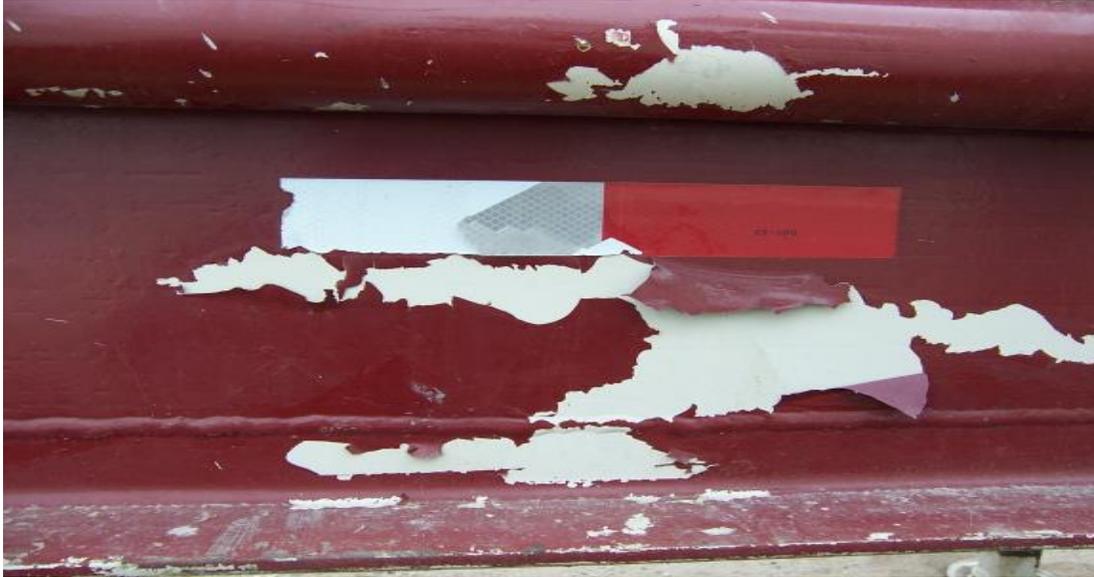
PEELING/DELAMINATION

Description: A loss of adhesion, or a separation of the paint film from the substrate.

1. Improper preparation of the substrate (sanding and cleaning).
2. Omitting or applying an incompatible undercoat to a specific substrate (e.g. aluminum, galvanized, plastics, etc.).

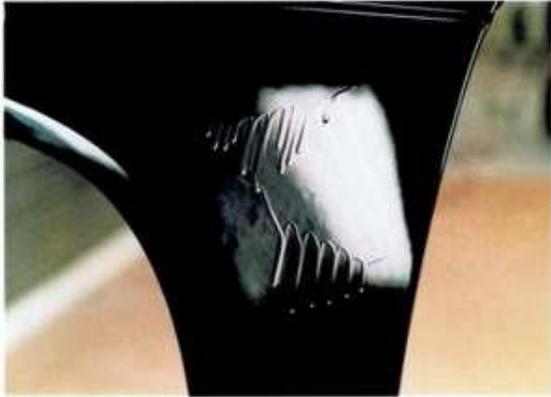
Photo

RUNS

Description: (Hangers, Curtains, Signatures) Coatings that fail to adhere uniformly, causing beads, droplets, or slippage of the total film.

1. Over reduction and/or too slow evaporating thinner/reducer.
2. Applying paint materials without proper flash time between coats.
3. Applying excessive wet coats due to:
 - a. Holding the gun too close to the surface
 - b. Slow gun speed;
 - c. Double coating.
4. Air pressure too low during spray application.
5. Improper spray gun set-up or an unbalanced spray pattern.
6. Material and/or substrate temperature too cold.

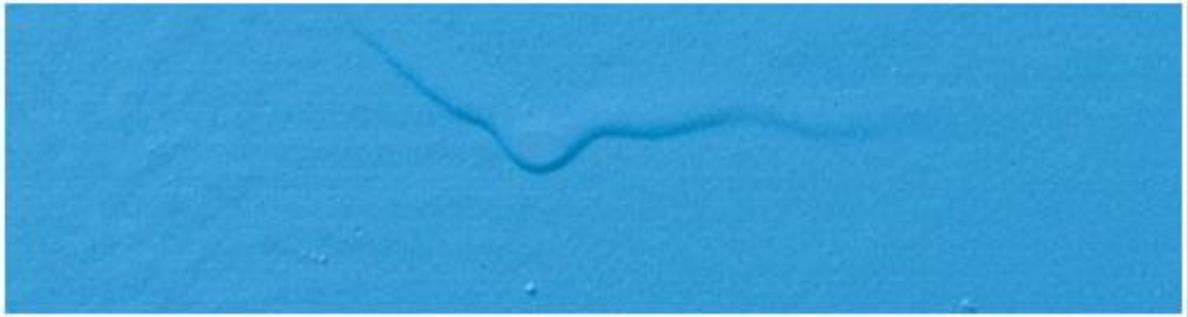
SAGGING

Description: Downward “drooping” of the paint film immediately after application, resulting in an uneven coating.

1. Application of too heavy a coat of paint.
2. Application in excessively humid and/or cool conditions.
3. Application of over thinned paint.
4. Painting over a glossy surface, which does not provide enough of a profile to which the coating to adhere to.
5. Painting over a surface contaminant.

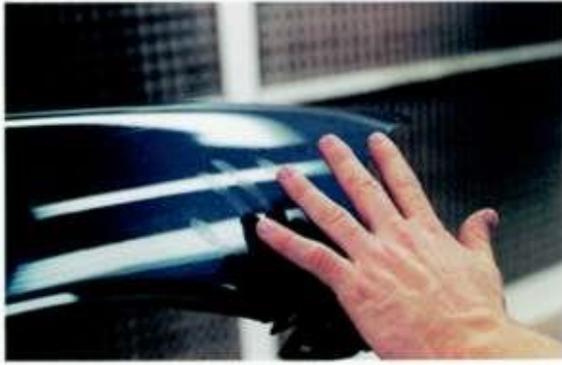
Photo 1

SOFT FILM

Description: (Slow Dry) The paint film is soft to the touch, and will fingerprint or water spot within hours/days after application.

1. Applying undercoat and/or topcoat excessively wet.
2. Insufficient dry time between coats.
3. Improper shop ventilation or heating.
4. Adding too much, or too little hardener to the paint material.
5. Using the *incorrect* hardener for the paint material.
6. Using the incorrect thinner/reducer for spray conditions.
7. Omission of drier in enamel/urethane topcoats.

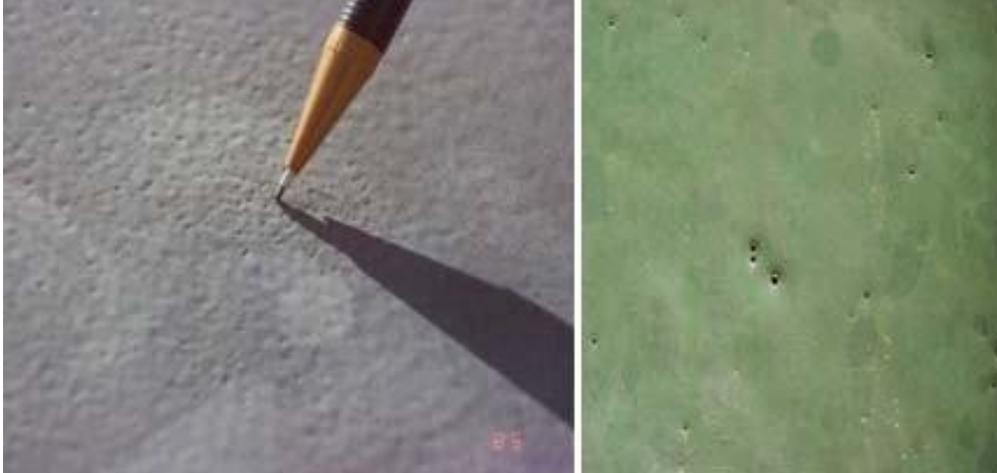
Photo 1

SOLVENT POPPING - PIN-HOLING

Description: (Boiling, Blowing) Small bubbles, pinholes or crater-like openings in, or on the paint film.

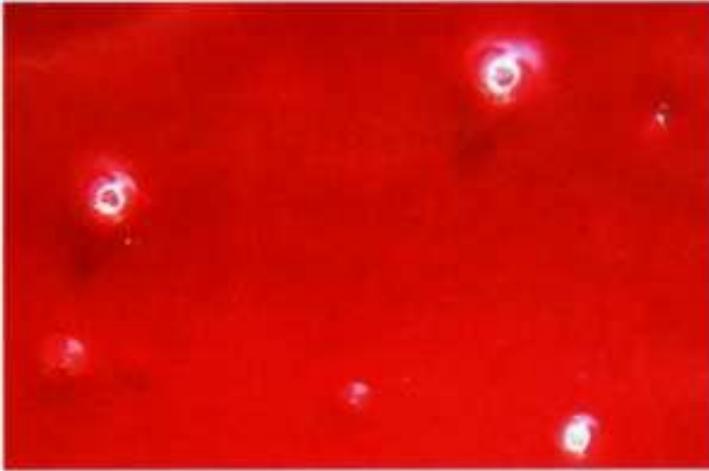
SOLVENT POPPING - PINHOLING (continued)

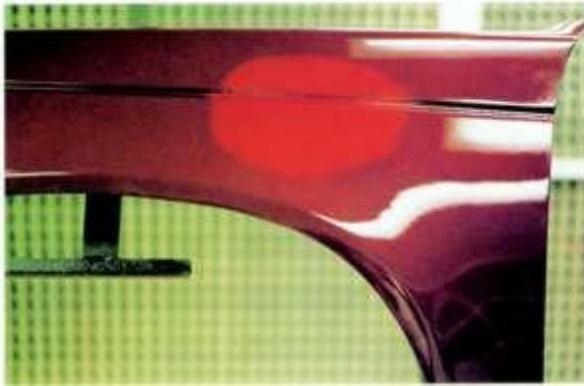
Photo 1

TRANSPARENCY

Description: (Poor Hiding, Poor Coverage, Translucent) The original finish or undercoat is visible through the topcoat.

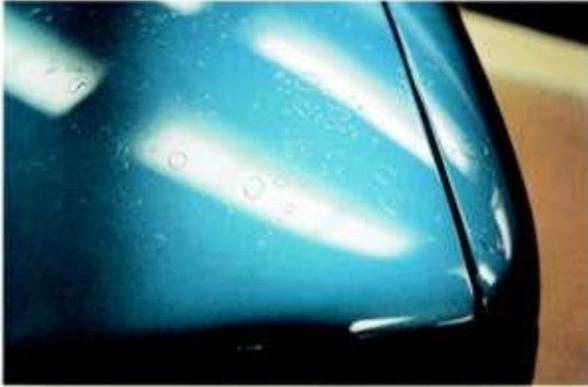
Figure 1

WATER SPOTTING

Description: (Water Marking) Circles with raised edges or whitish spots resembling the various shapes of water droplets appear on the surface of the paint film.

1. Allowing water to come into contact with a finish that is not thoroughly dried/cured (Fig. 1).
2. Washing finish in direct sunlight (Fig. 2)
